**Flood Control Project Maintenance
Levee Inspections**

2013 Channel Summary Report

San Joaquin County Flood Control and Water Conservation District

Duck Creek Diversion Channel

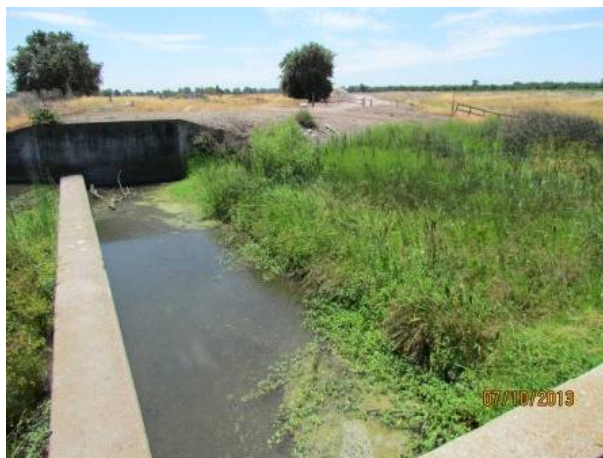
pkazi_c_20130715_082.JPG

View of the vegetation in the channel downstream of the diversion channel.

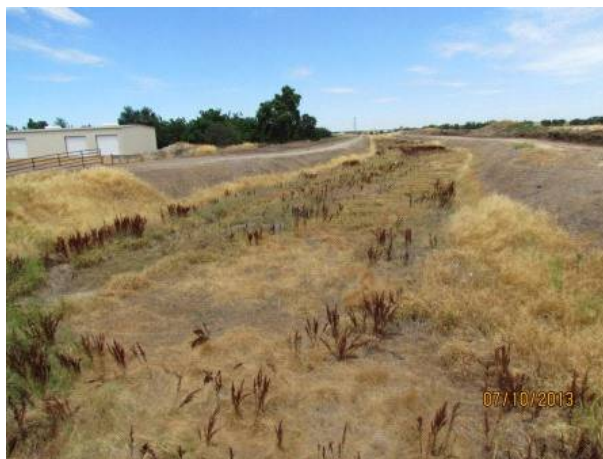
pkazi_c_20130715_083.JPG

View of the vegetation on the channel looking upstream.

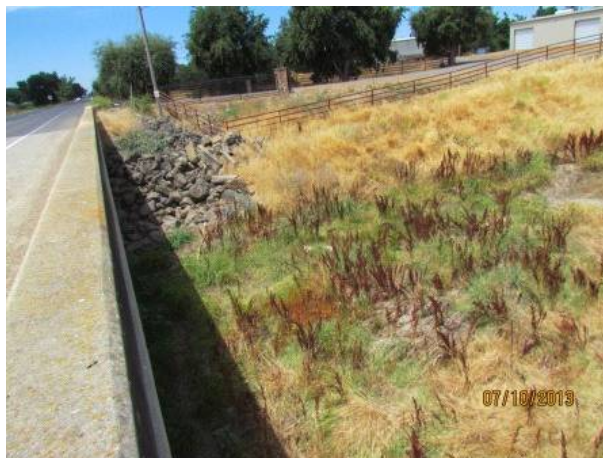
pkazi_c_20130715_084.JPG

View of the revetments on the right bank of the channel looking upstream.

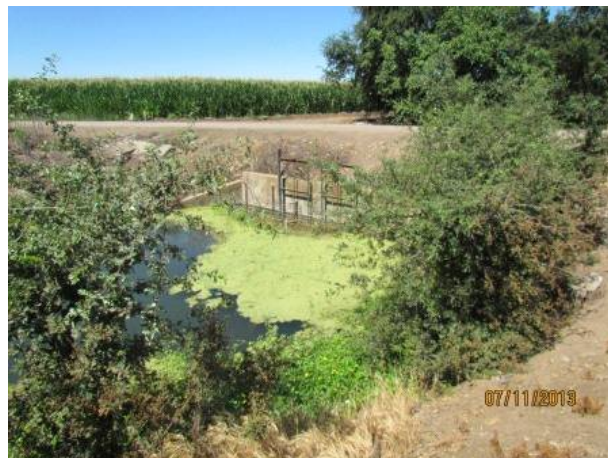
pkazi_c_20130725_103.JPG

View of the concrete surface of the culvert looking from the upstream end of the channel.

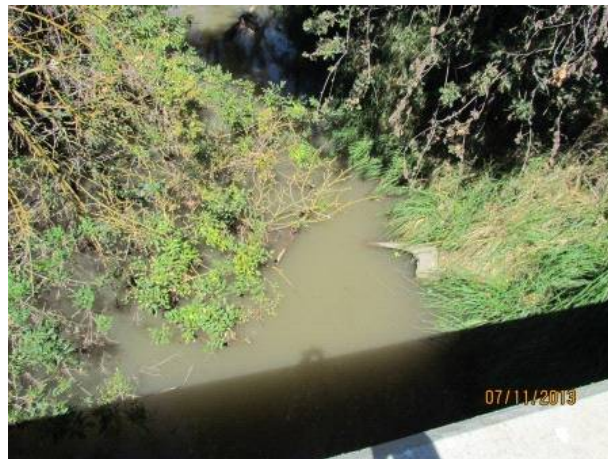
pkazi_c_20130726_108.JPG

View of the broken pipe on the downstream end of the channel.

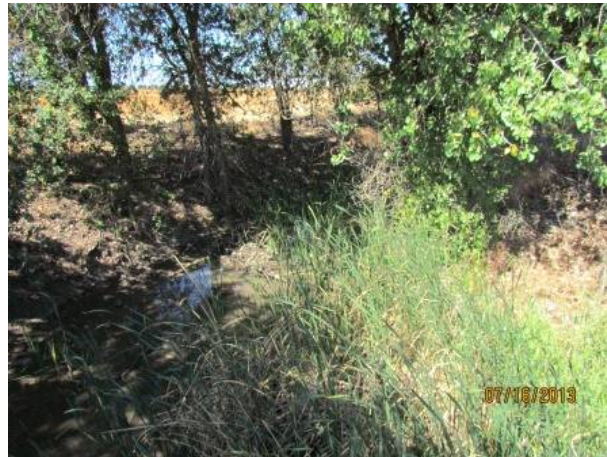
Levee Mile Report Line	46
Start Levee Mile	0.00
End Levee Mile	0.00
Location	
Category	Channels
Item	Encroachments
View of debris in the downstream end of the channel.	
pkazi_c_20130805_129.JPG

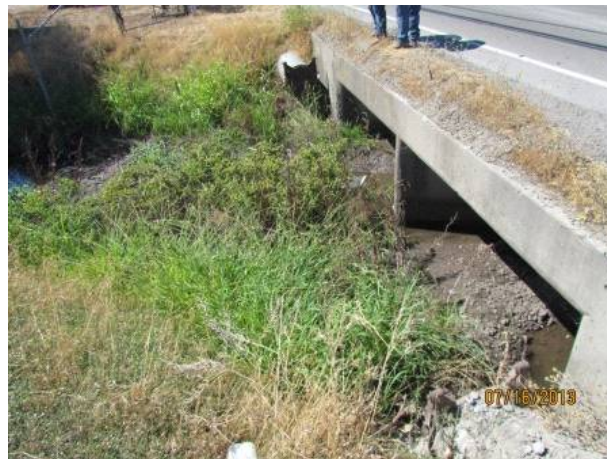
pkazi_c_20130805_132.JPG

View of the encroachments on the upstream of the channel.

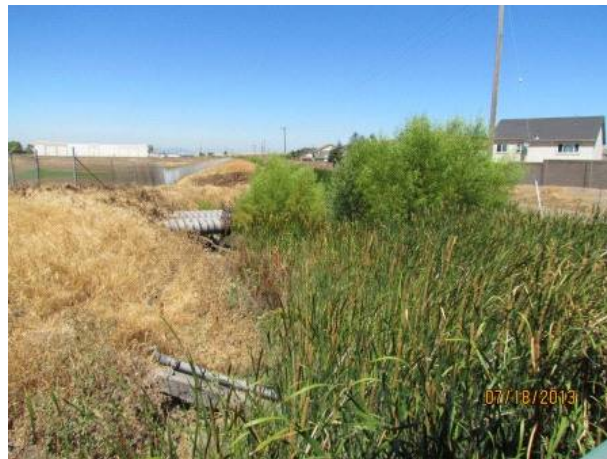
pkazi_c_20130805_146.JPG

View of the heavy vegetation on the downstream of the channel.

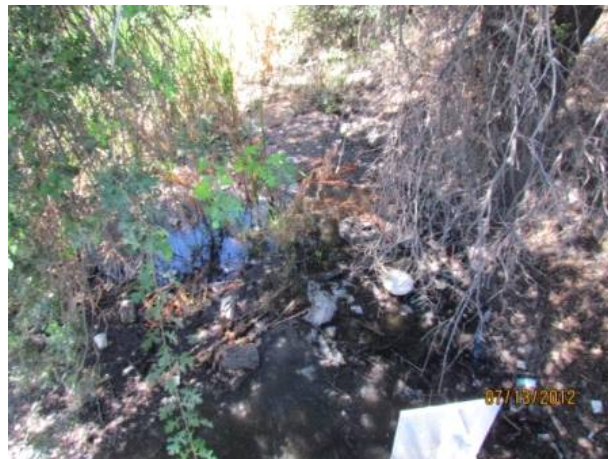
pkazi_c_20130618_029.jpg

View of the encroachments on the downstream end of the channel.

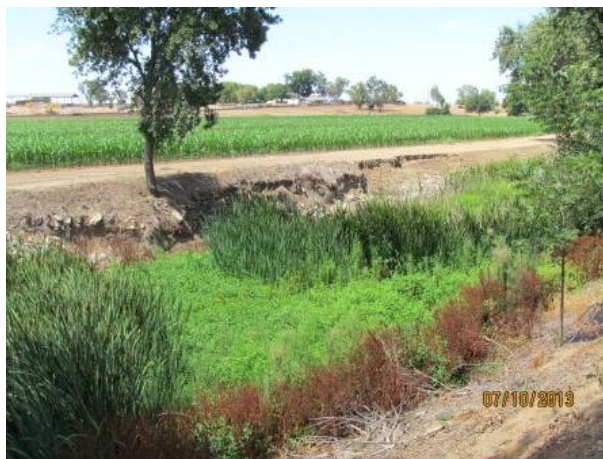
pkazi_c_20130715_076.JPG

Erosion was found on the channel banks looking downstream.

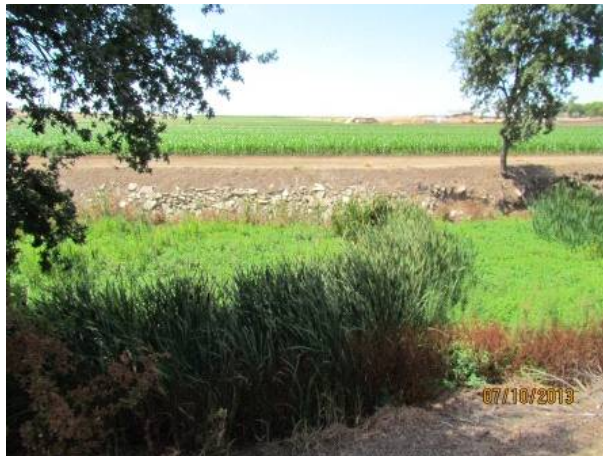
pkazi_c_20130715_077.JPG

Existing revetments are not properly maintained and appeared to be damaged. The picture was taken looking downstream of the channel.

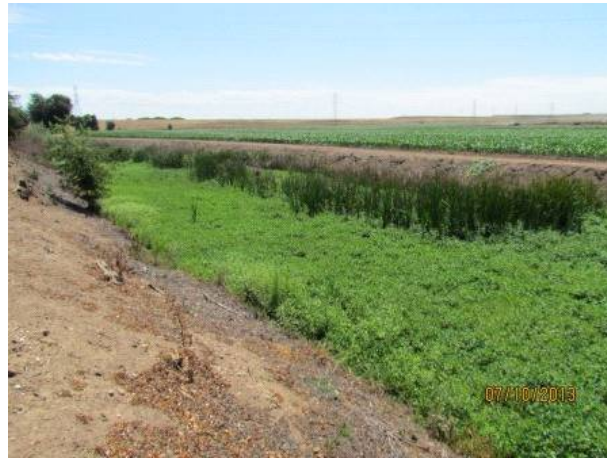
Levee Mile Report Line	6
Start Levee Mile	0.00
End Levee Mile	0.00
Location	
Category	Channels
Item	Vegetation & Obstructions
View of the vegetation that may impede the flow of the channel. The picture was taken looking upstream.	
pkazi_c_20130724_090.JPG

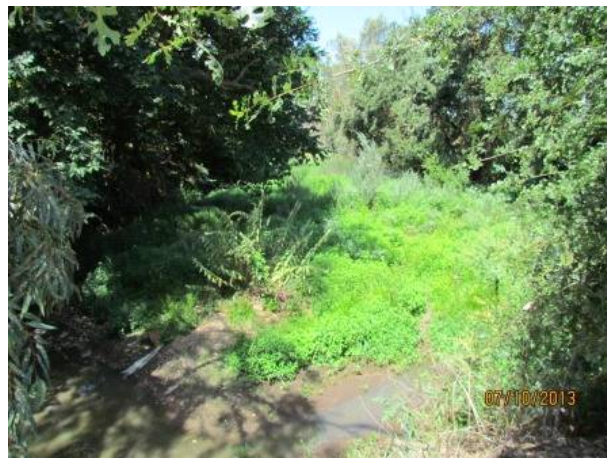
Levee Mile Report Line	13
Start Levee Mile	0.00
End Levee Mile	0.00
Location	
Category	Channels
Item	Vegetation & Obstructions
View of heavy vegetation on the downstream of the channel.	
pkazi_c_20130724_092.JPG

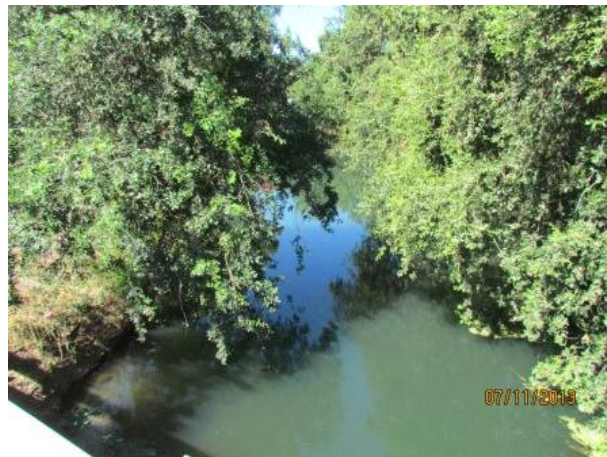
Levee Mile Report Line	32
Start Levee Mile	0.00
End Levee Mile	0.00
Location	
Category	Channels
Item	Vegetation & Obstructions
Tree braches might obstruct the flow of the channel looking downstream.	
pkazi_c_20130725_100.JPG

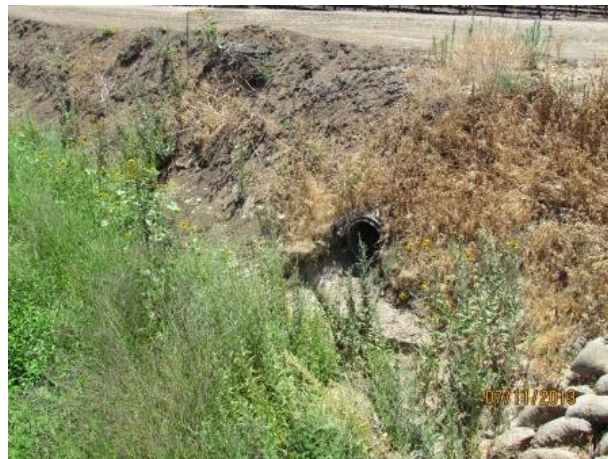
pkazi_c_20130802_123.JPG

View of broken pipe and other debris on the downstream of the channel.
